## Memorandum

Pre-CERCLIS Screening Assessment of the Divide Mine (Grants Mining

District), McKinley County, New Mexico:

Further Investigation under CERCLA Recommended

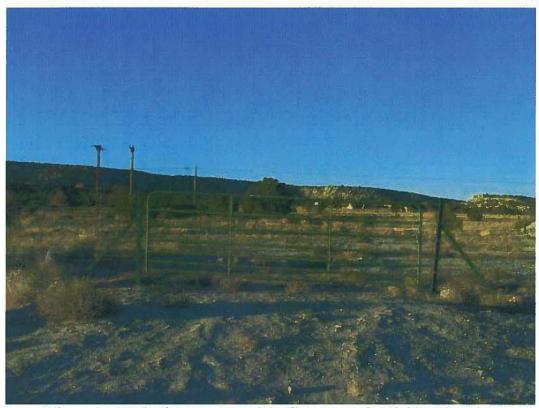
Photo 1. Locked gate on road leading towards Divide mine site
